Maintenance and upgrade of the 60 kW RF Amplifiers for the 70 MeV Cyclotron at LNL

INFN-LNL-279/2024

April 18, 2024

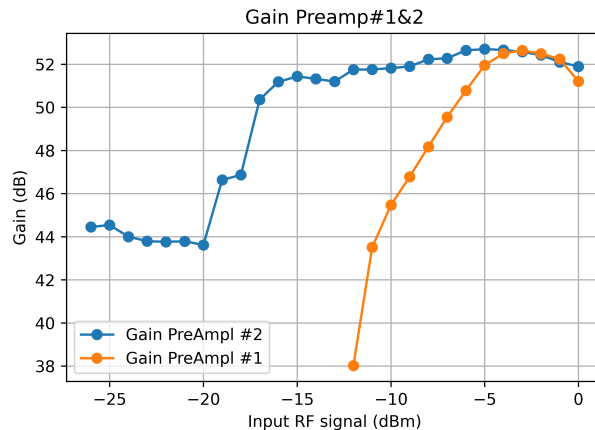
Figure 2: Gain comparison between Predrivers

In the Figure 2 the gain plots resulted from the measurements are directly compared, and clearly highlights that the lack of power output for unit 1 comes from a malfunction of the predriver 1. The plot highlights also a poor linearity

in the gain response that it was suppose to be 52 dB on a wide input range for both predrivers. After this result the predrivers were removed from the units and tested again at the bench for further inspections, the new results was comparable, but also other behaviours appear clear for both predriver. After few hours of operation at constant power output of 50 W, to ensure the correct thermalization of the units, both predrivers at low power output (up to 15 W) exhibit a very unstable and noisy gain. In Figure 3 the plot of the gain instability. For reference on both units, with a very stable RF signal at 56.2 MHz of -19 dBm at the input, on unit 2 at the output we observed a jump from a minimum 31.14 dBm to maximum 33.62 dBm a delta in gain of 2.48 dB, and on unit 1 at the output we observed a jump from minimum 20.0 dBm to maximum 32.04 dBm a delta in gain of 12.04 dB. This clearly highlights that the problems of unstable power output from the two RF amplifier units during the low power conditioning operations comes from the predriver behaviour.

The only acceptable and available short term solutions for stable operation was to substitute the original predrivers with two power amp units with a similar gain. This temporary units are the linear wide band solid state class A power amplifier ENI 3100LA, installed in the LLRF rack, powered from the RF Amplifier units and connected directly at the Drivers inputs.

Due to the problem encountered and obsolescence of the electronic parts for the Predrivers units, it's necessary an up to date, maintainable and reliable system. A document with all specifications needed for replacement of the units was drafted. The suggestion is to use an external solid state amplifier, similar to those normally used at LNL for ALPI operations.

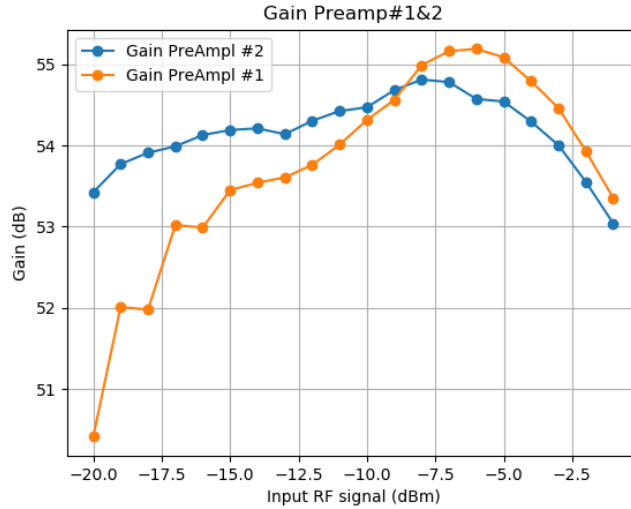
Figure 4: Predrivers Gains after BIAS regulations

After this diagnosis, the BIAS of the sections were adjusted to improve the situation of the amplifier 1 and 2; the results wasn't effective, if a better low end gain response was reached (Figure 4), the gain instability and the distortion

(Figure 5 and Figure 6) was still present and problematic for the operations of the Driver and the Final stages.

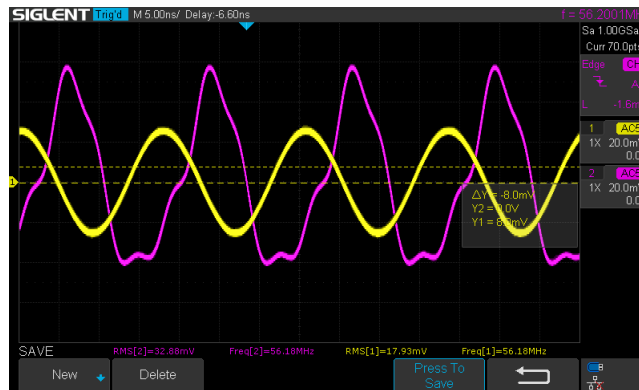
Figure 5: Distortion on Predriver 1

Moreover for the units was found a high output distortion level in all input range, the pure sinusoidal signal at the input of the predriver, provided from a calibrated R/S SMB100 RF generator (sampled with a directional coupler and then acquired at CH1 of an 350 MHz Bandwidth oscilloscope), at the output of the predriver (sampled with an appropriate directional coupler and then acquired at CH2 of the oscilloscope), connected to an appropriate and 50 Ω adapted load, appear distorted.
